NACA TN 3190

FATIGUE INVESTIGATION OF FULL-SCALE
TRANSPORT-AIRPLANE WINGS

SUMMARY OF CONSTANT-AMPLITUDE TESTS THROUGH 1953

By M. J. McGuigan, Jr., D. F. Bryan, and R. E. Whaley

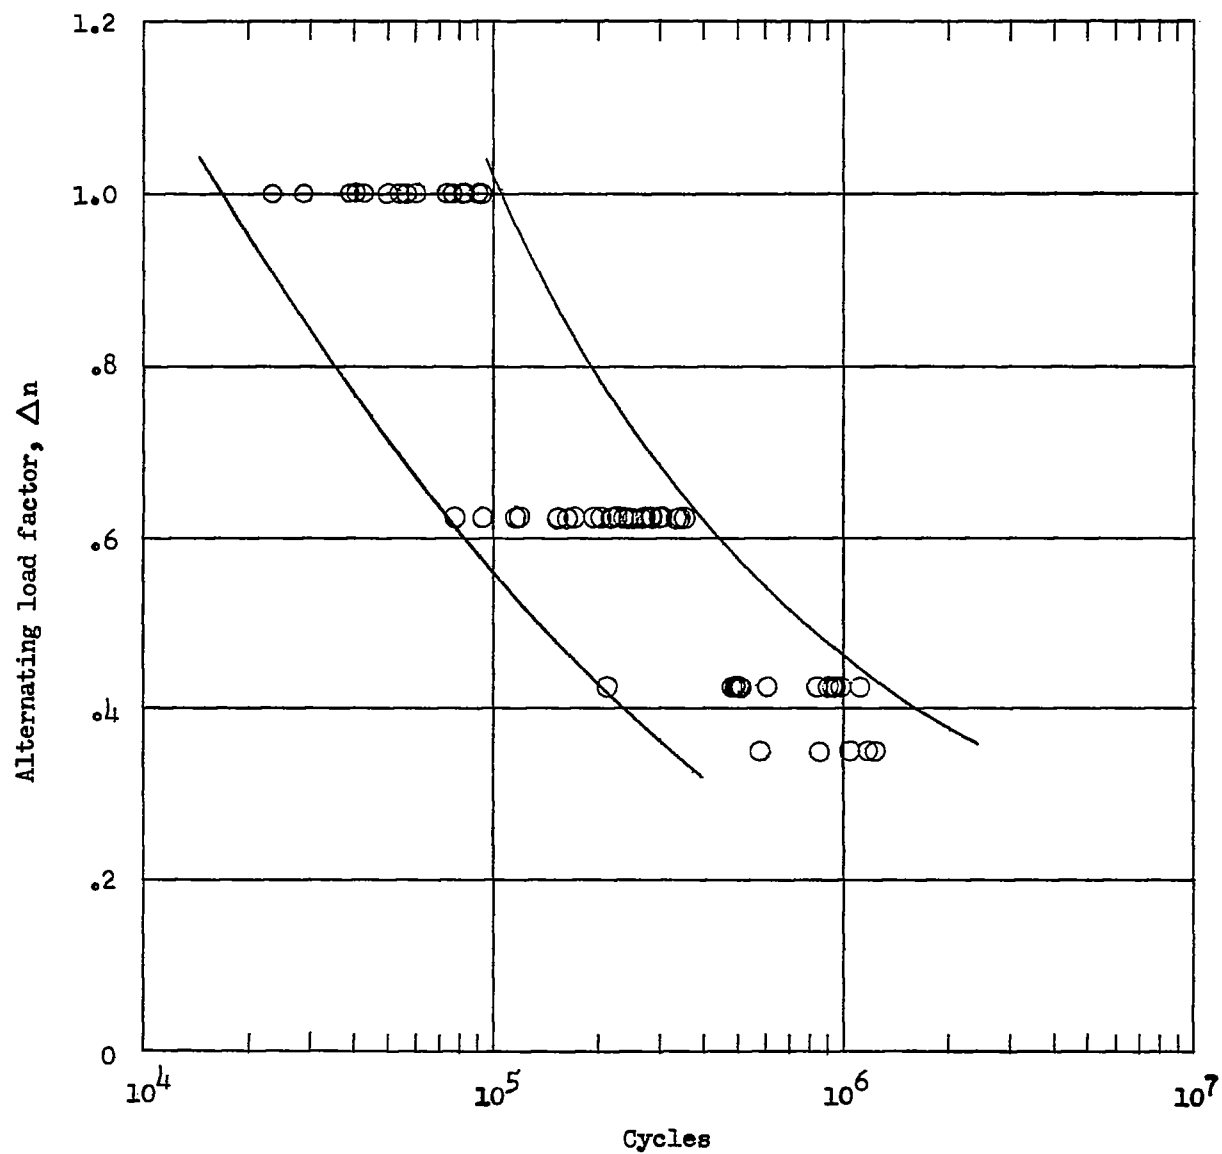
Figure 9.- Load-lifetime diagram for initial failure showing scatter band for 95-percent probability.

The number of cycles to initial failure is included in table 1. The fatigue life for this structure at the various test levels appeared in figure 9 in the form of a load-lifetime diagram. This figure showed the load-lifetime diagram for initial failure, as previously defined, for all failures that occurred during the tests. For no apparent reason some of these failures never grew to more than an inch in length, while others grew to a considerable size. In figure 12 is shown the load-lifetime diagram of initial and final failure for those failures that grew until their respective crack-propagation curves indicated that the critical percentage of tension material had failed. The number of cycles to final failure, estimated from the individual crack-propagation curves for each of the failures, is listed in table 1. It is evident from the rate of crack growth indicated by the curves of figure 11 that this estimate would not be much in error.

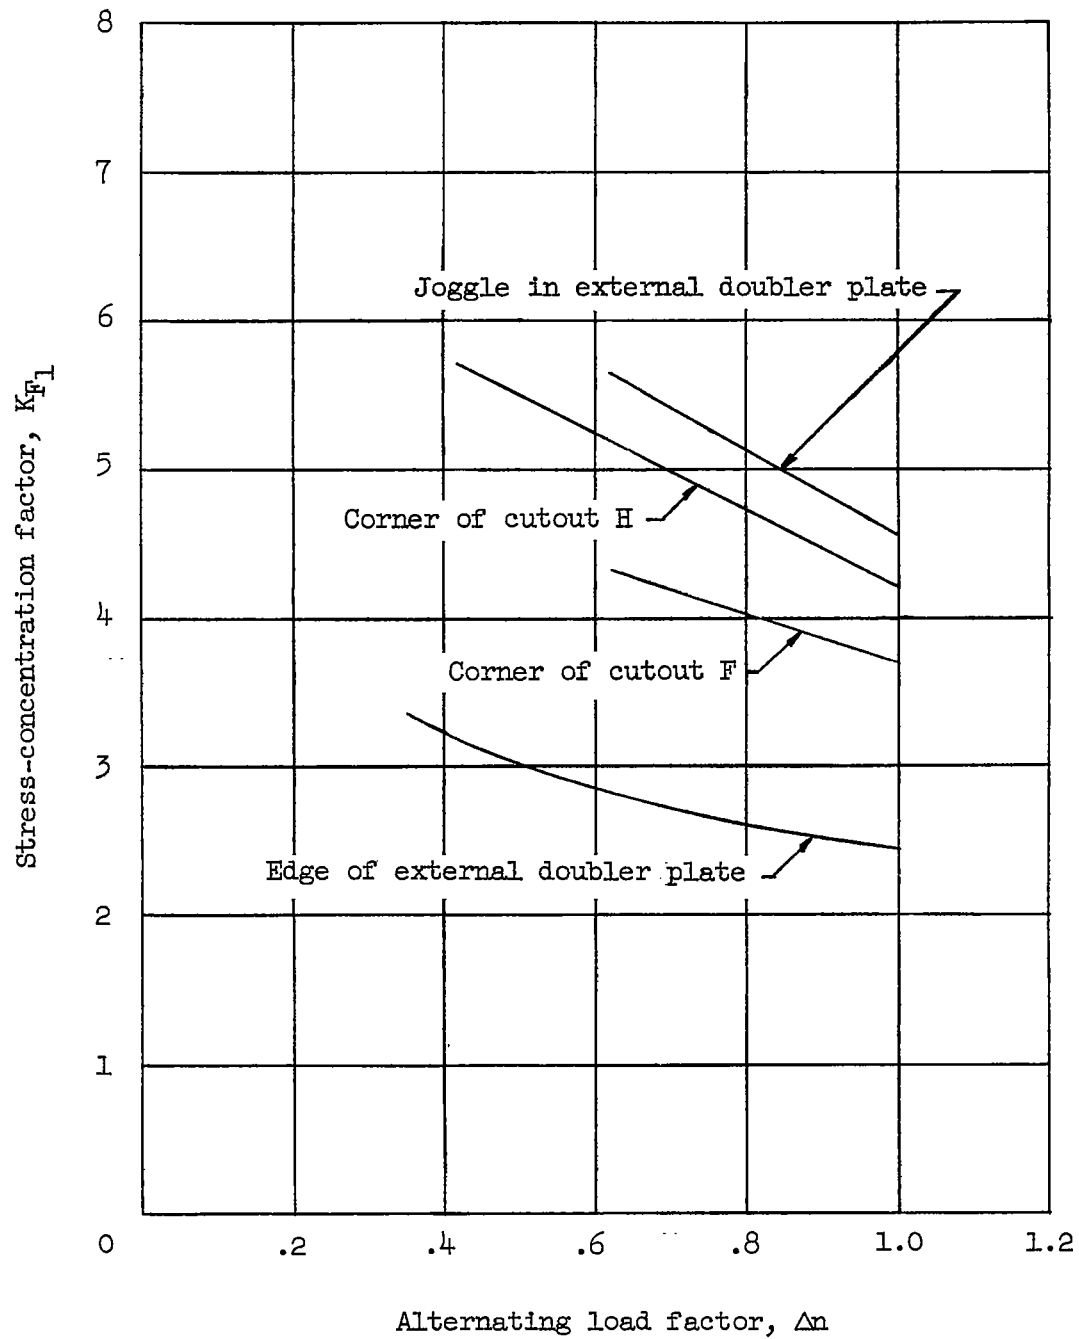
Figure 10.- Effect of load level on the stress-concentration factor.

The range of concentration factor K_{F1} occurring at each load level for the five types of failures is shown in table 2. It can be noted from this table that the concentration factor tends to decrease with increasing load level. This trend is shown graphically in figure 10 for several locations where failures occurred at more than one load level. The trend is assumed to be caused by the increasing effects of plasticity associated with higher stresses as the load level is increased. Both K_{F2} and K_{F3} show the same decreasing trend with increasing load level that K_{F1} does, but in the case of K_{F3} the trend is not very apparent because of the lower magnitudes involved.

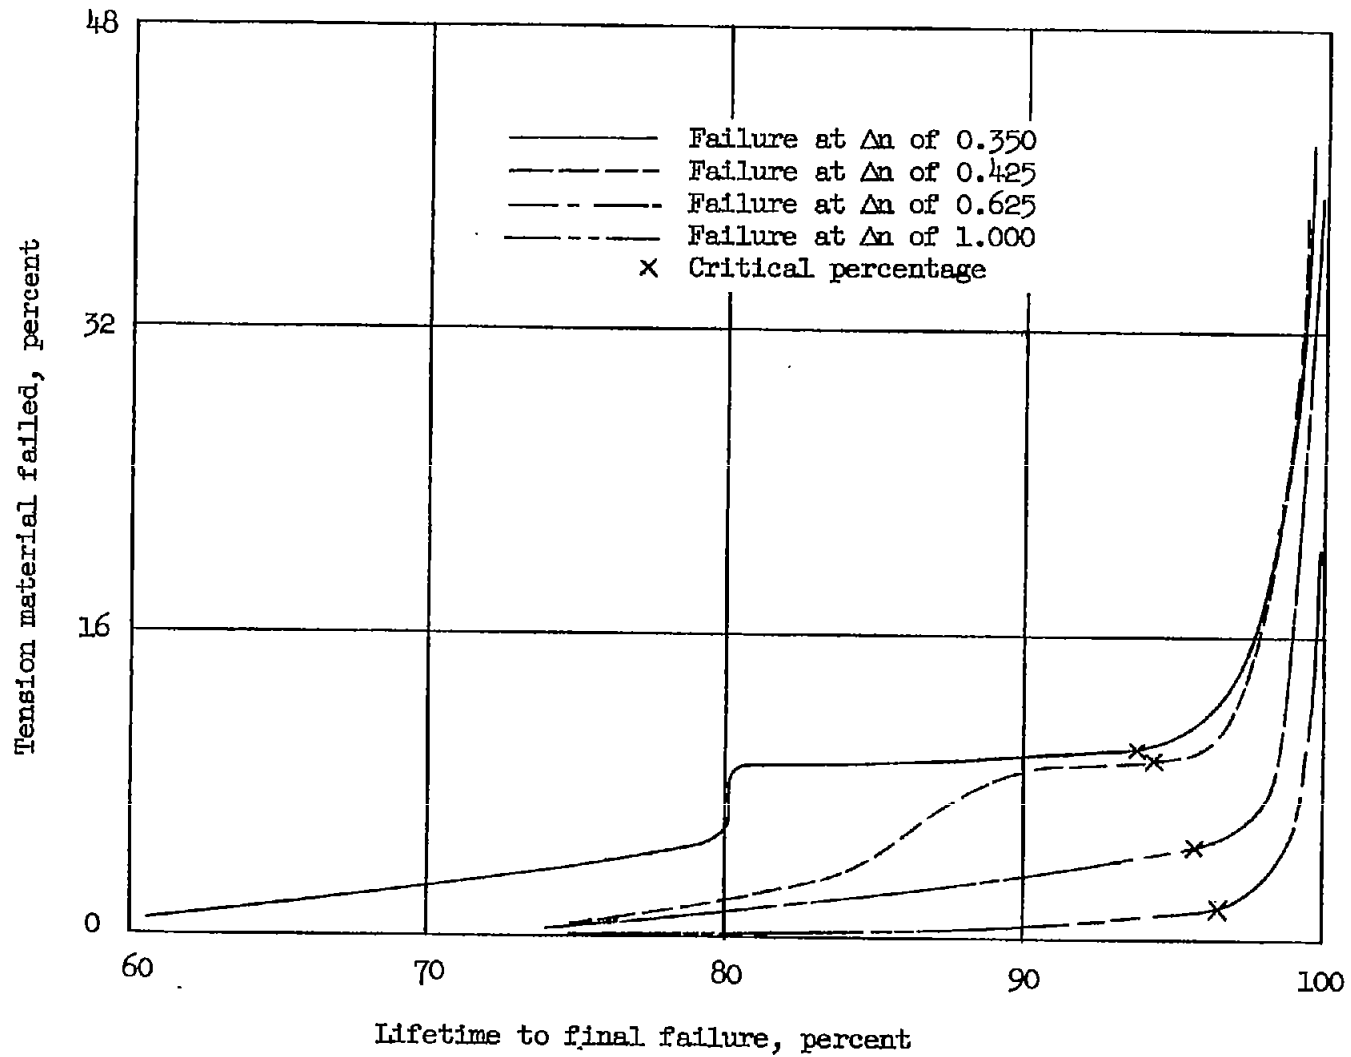
Figure 11.- Typical fatigue-crack propagation.

The growth of all fatigue cracks was observed during the course of the tests. In figure 11 the growth of typical failures is plotted for each of the test levels. In order to put all failures on the same comparative basis, the percentage of tension material failed in a cross section of the wing is plotted against the percentage of lifetime to final failure. In this figure it can be noted that all of the curves have the same general shape. In each case the failure grew slowly until a certain percentage of the tension material had failed. At this point, defined as the critical point, the growth of the cracks became very rapid. The percentage of tension material that had failed at the critical point decreased with increasing load level. For the 0.35g level the amount of tension material that had failed at the critical point was about 10 percent; for the 0.425g level, about 9 percent; for the 0.625g level, about 6 percent; and for the 1.0g level, about 2 percent. This critical point occurred at about 95 percent of the lifetime to final failure for all test levels. Tests of all specimens were continued until the critical point had been determined.

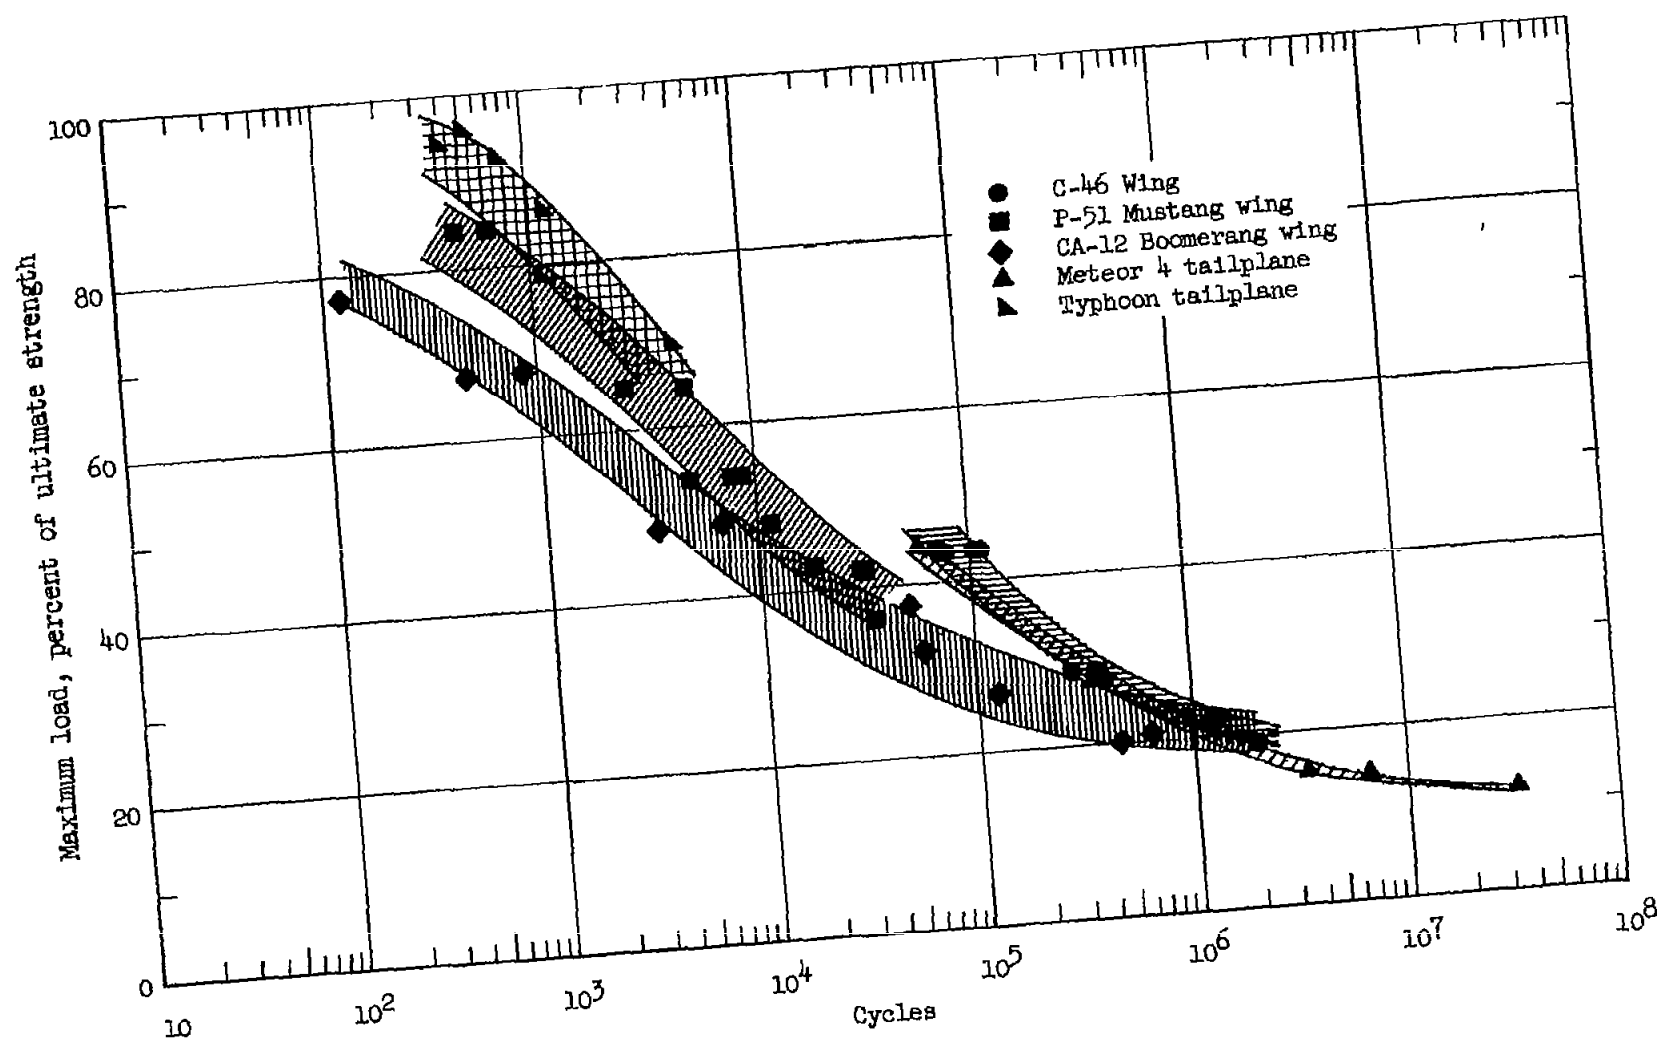
Figure 13.- Load-lifetime diagrams for several aircraft structures.

The load-lifetime diagram for final failure is presented in figure 13, along with results of fatigue tests on a number of other airplane structures taken from references 7 to 10. The load is given in percent of the ultimate static strength of the structure. It can be seen from this figure that all of the full-scale data presented lie within a comparatively narrow scatter band, considering the fact that the data include different types of airplanes and components with many types of stress raisers. Full-scale fatigue data from other airplanes have been found to fall within the scatter of the data that are presented.

Since the ordinate of figure 13 is based on the ultimate strength of the structures and since fatigue failures occurred principally on the tension surface, the load-lifetime comparison could best be made on the basis of the ultimate strength of that surface. In the static tests to determine the ultimate strength of the structures in references 7 to 10, the P-51 wing and Meteor 4 tailplane failed in compression while the remaining structures failed in tension. The C-46 curve in this figure is based on the design ultimate strength of the wing, because the actual ultimate strength is unknown. In static tests performed by the U. S. Air Force the wing failed in compression at 95 percent of the design ultimate load, and was subsequently reinforced but not retested.

If, in the case of those structures which failed in compression, the strength of the tension surface is assumed to be greater than the strength used in the comparison of figure 13, the load-lifetime curves would be shifted downward. This downward shift would very likely result in even less scatter in the data of this figure than is now present.
